UNITED STATES DEPARTMENT OF AGRICULTURE
FOREST SERVICE

October 12, 1970

SUBJECT: Investigation of California Black Oak Failure on
Mountain Empire Power Company R.O.W., Troy Canyon,
Descanso District, Cleveland National Forest.

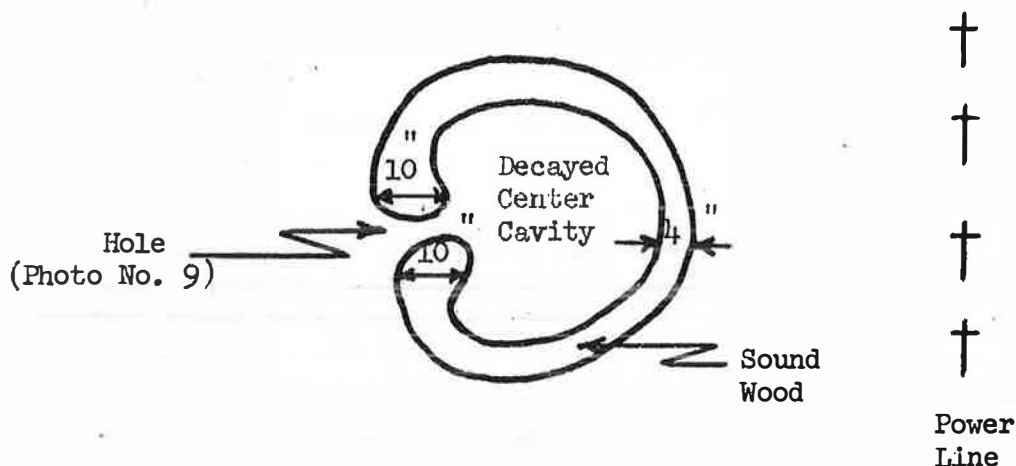
The diameter of the tree below the main fork at 3 feet, 6 inches above the ground was about 40 inches. The tree was forked at about 63 inches above the average ground line. The diameter of the bole leaning towards the power line was about 24 inches (measured just above the fork). The diameter of the main bole was about 33 inches just above the fork (Photo No. 12).

The defect was primarily a loss of mechanical strength in the two main boles of the tree. The heartwood (the major center and inside portion of a tree bole) was almost completely decayed and broken down by fungal activity prior to the fire. The large holes with the rounded edges formed by sapwood callus tissue would have revealed this condition prior to the fire (Photo Nos. 4 and 5, 7 through 11 and 13).

The main bole in cross section at 3 feet above the ground looked about like this:
